HOMC APPLICATION NOTE-1

Corrosion Assessment Under Welded Supports / Saddles

30inch Discharge Line Welded Support Failure Assessment Case Study

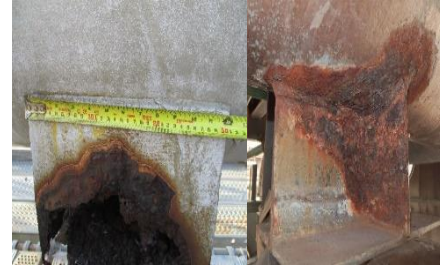
The typical source of corrosion is water ingress and accumulation of water under the pad leading to corrosion that can lead to failure with no warning signs due to the very localized nature of the problem and corrosion profiles.

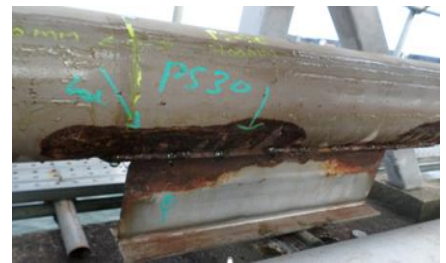
The welds on the periphery of the pad tend to reflect Ultrasonic signals and detection and sizing of localized corrosion under same under the pad can be challenging, or results could be skewed.

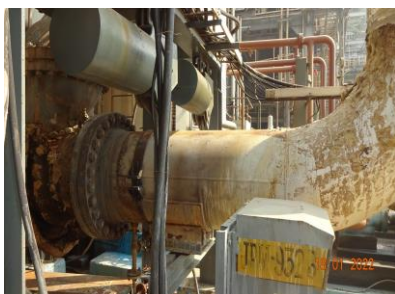
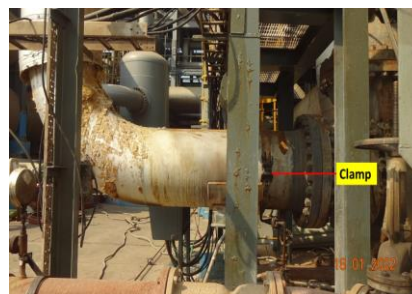
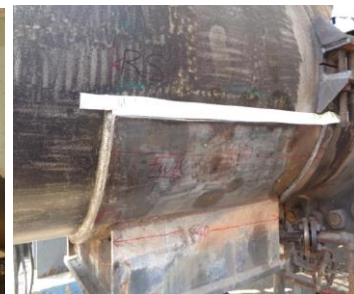
A leading Petrochemical plant experienced a failure at a Welded Support of a 30inch discharge line with no signs of visible corrosion at the region of failure. A Clamp repair was done towards the end of the support where the leak was observed. The aim of the inspection was to assess the condition of the pipe under the welded support with HOMC.

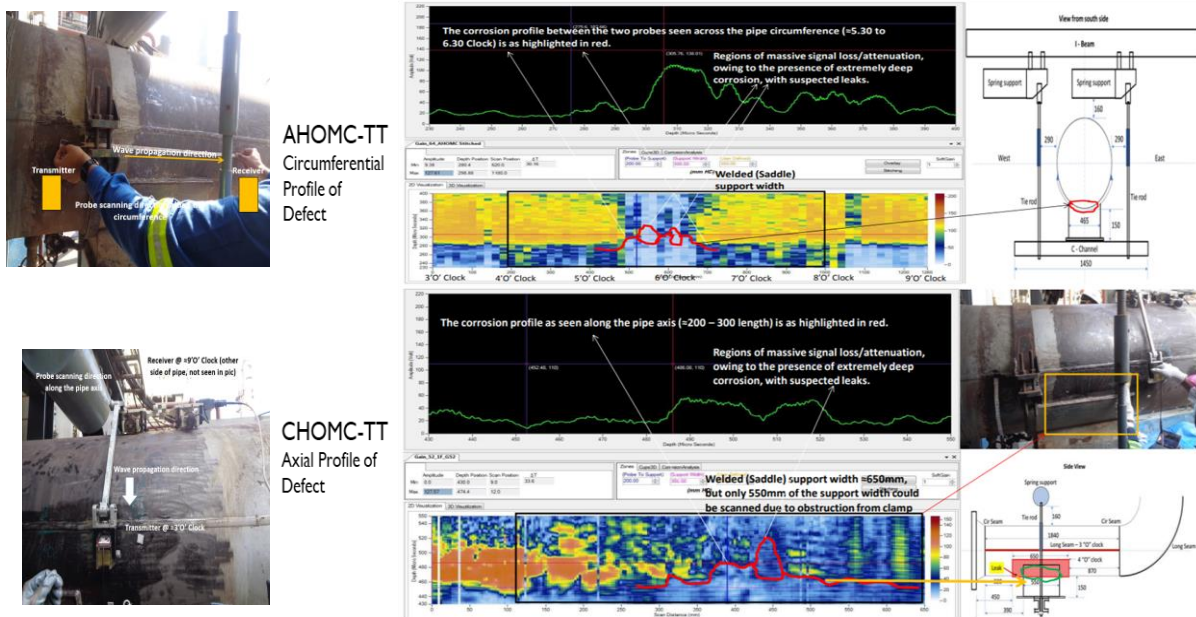
An Axial HOMC Through Transmission (AHOMC_TT) mode inspection was done with the probes placed on either end of the support facing each other to assess the corrosion profile and wall loss across the circumference which was found to be presented between 5½ and 6½ clock positions

A Circumferential HOMC Through Transmission (CHOMC-TT) mode inspection was done in addition to estimate the corrosion along the length of the support and the inspection revealed corrosion along the entire length with an average of 71-80% wall loss along with some deep localized spots with >80% wall loss based on a nominal wall thickness of 15.88mm.

A subsequent inspection of the saddle for its integrity was also done which revealed no major findings on the saddle itself confirming the corrosion to be on the discharge line under the support. Precise engineering assessment was done based on HOMC Inspection findings by the client to determine safe continued operation.
