HOMC APPLICATION NOTE-4

Corrosion Assessment Under Composite Sleeves

Corrosion Assessment Under Composite Repair Sleeves

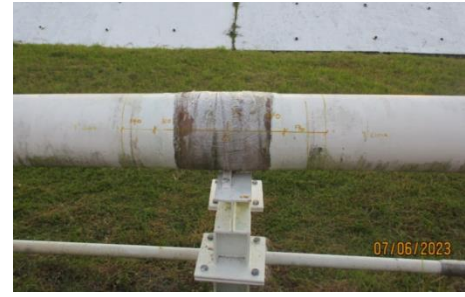
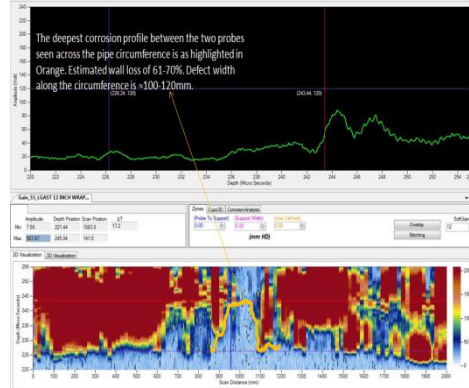
HOMC INSPECTION of 12 inch Wrapped Pipe - 1

A 12inch hydrocarbon Line at a Terminal was repaired with a planned replacement of the repaired section scheduled over a specific window. There was an existing wall loss of around 65-70% of the nominal wall thickness seen earlier leading to the repair. When a delay to the replacement of the section happened, the integrity of the pipe under the repaired composite wrap section was to be done to allow for continued operation. The original measurements taken before repair was compared with HOMC estimates of the corrosion profile and wall loss determined and the inspection confirmed the exact location of the corrosion and also the depth of wall loss which was not found to be different then determined before the repair to allow the client to make an estimate of existing condition of the pipe and thereby to allow for further continued service.

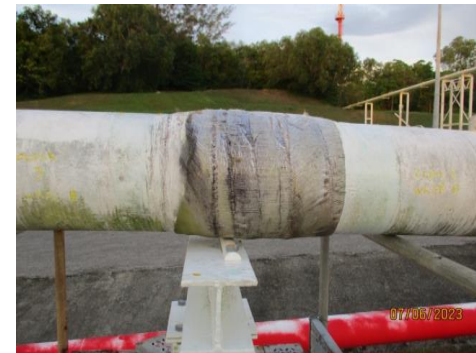
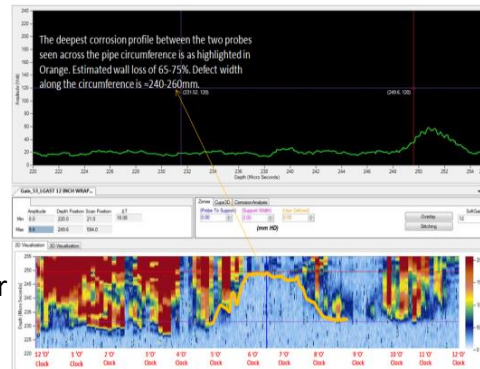
HOMC INSPECTION of 12 inch Wrapped Pipe - 2

A 12inch hydrocarbon Line at a Terminal was repaired with a planned replacement of the repaired section scheduled over a specific window. There was an existing wall loss of around 65-70% of the nominal wall thickness seen earlier leading to the repair. When a delay to the replacement of the section happened, the integrity of the pipe under the repaired composite wrap section was to be done to allow for continued operation. The original measurements taken before repair was compared with HOMC estimates of the corrosion profile and wall loss determined and the inspection confirmed the exact location of the corrosion and also the depth of wall loss which was not found to be different then determined before the repair to allow the client to make an estimate of existing condition of the pipe and thereby to allow for further continued service.

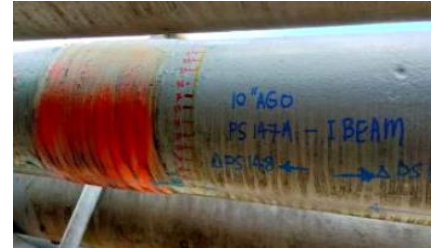
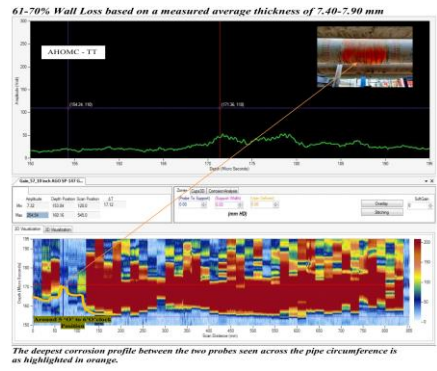
HOMC INSPECTION of 10 inch Hydrocarbon Line
 A 10inch hydrocarbon Line at a Terminal was repaired with a planned replacement of the repaired section scheduled over a specific window. There was an existing wall loss of around 60-65% of the nominal wall thickness seen earlier leading to the repair. When a delay to the replacement of the section happened, the integrity of the pipe under the repaired composite wrap section was to be done to allow for continued operation. The original measurements taken before repair was compared with HOMC estimates of the corrosion profile and wall loss determined and the inspection confirmed the exact location of the corrosion and also the depth of wall loss which was not found to be different then determined before the repair. to allow the client to make an estimate of existing condition of the pipe and thereby to allow for further continued service.

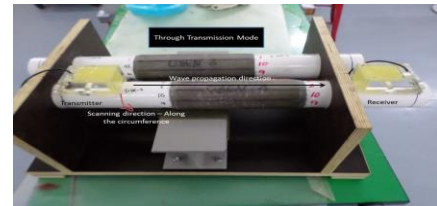
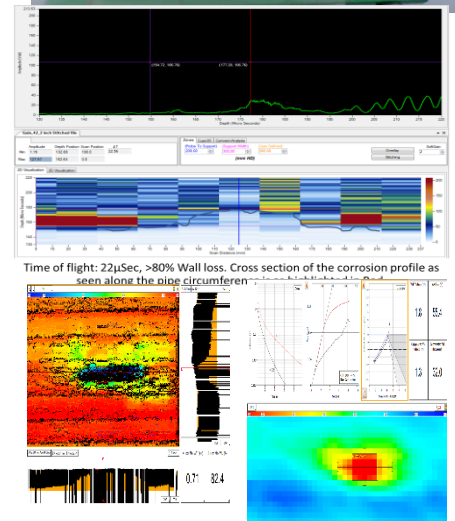
HOMC INSPECTION of 2 inch Wrapped Pipe
 A 2inch repaired composite wrapped sample was provided by a leading Petrochemical company with corrosion present under the wrap. The inspection was performed by Axial -TT HOMC and the results compared with Ultrasonic IRIS measurements and Pulsed Eddy Current. The defects were mapped very accurately by HOMC and sizing levels were extremely precise when compared with Ultrasonic IRIS measurement (>80% by HOMC and 82.4% by IRIS) .Pulsed Eddy Current based on inherent sizing ability was under sizing the defects by around 10%. The advantage of HOMC is that it not to be affected by the wrapping and through transmission technique deployed are amplitude independent to provide accurate defect profile and sizing.
