HOMC APPLICATION NOTE-5

Corrosion Assessment Under Scabbing

HOMC Guided Waves as Reliable Solution

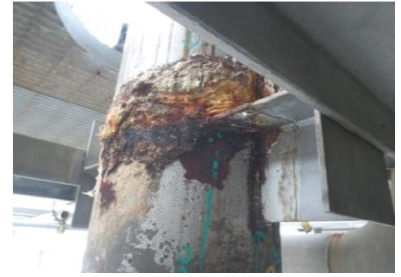
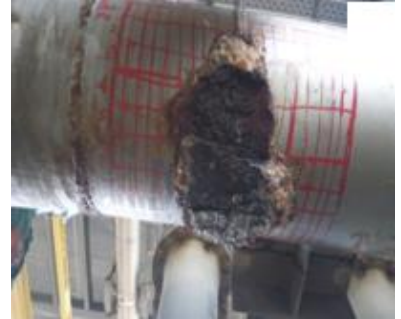
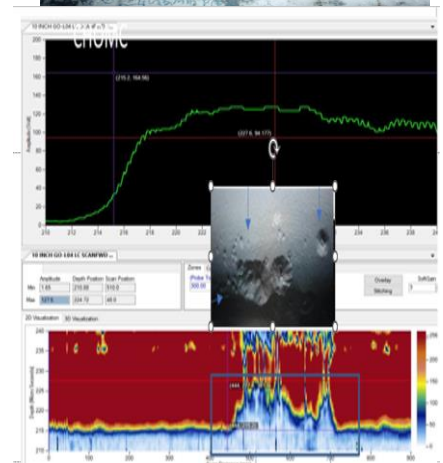
The Higher Order Mode Cluster (HOMC) Ultrasonic Guided waves can be deployed axially in through transmission mode (AHOMC-TT) for pipes with access to the region of interest such as elevated pipes, elbows etc. Pipes with no access to the bottom or closely spaced pipes can be inspected from the top with probes at 2 and 10 'o' clock positions Circumferential HOMC in TT Mode (CHOMC). Not only the depth of wall loss but the profile of corrosion is also determined with extreme high sensitivity to the deepest wall loss. The sizing accuracy is in the range of 20-80% Wall loss. It can be deployed from 2 inches and above pipe sizes

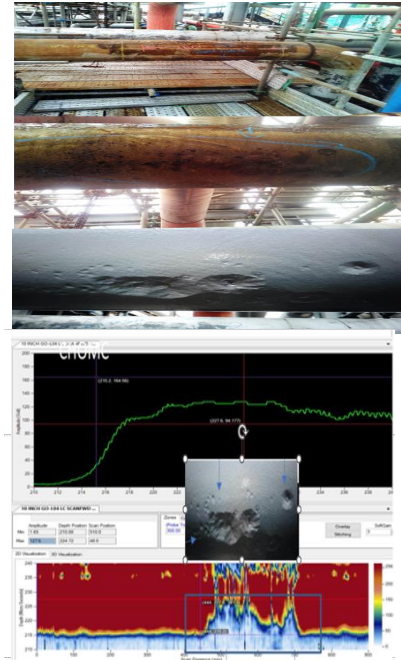
HOMC INSPECTION of 10 inch pipe with Scabbing

A 10inch hydrocarbon at a refinery with scabbing corrosion was inspected with HOMC to assess severity as the client wanted to determine the severity of corrosion prior to blasting and doing necessary maintenance to contain the corrosion.

Through Transmission CHOMC was carried out and the corrosion profile and depth was determined.

Subsequent blasting and maintenance done during an outage revealed a close correlation in defect profile and sizing estimates. The ability to size small localized corrosion on larger general corrosion was very useful to determine the risk levels under scabbing and to suitably plan further maintenance actions

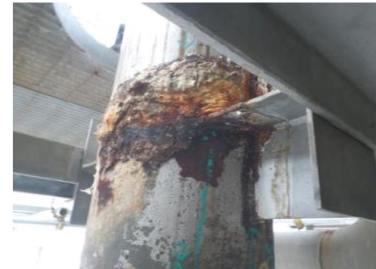
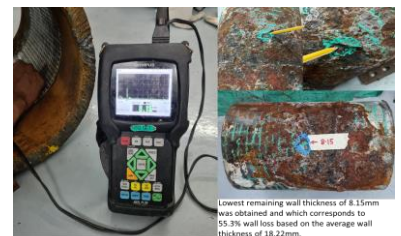
HOMC INSPECTION of Scabbing with a welded guide

A 12inch pipe with scabbing and a welded support guide provided some challenge to determine the deepest corrosion point by Pulsed Eddy Current to the client at support region due to interference efforts. Initial Pulsed Eddy Current done revealed a wall loss of around 30% Wall loss. HOMC was also done at site and revealed a wall loss of 51-60%. The pipe was subsequently replaced and the cut sample was brought back for further evaluation.

Without interference from the welded support in the cut sample, Pulsed Eddy Current sized the defect as 54.5% Wall loss with a High Resolution Scabbing Probe.

Ultrasonic Grid mapping done from the pipe internal revealed a wall loss of 55.3%.

The accuracy of HOMC under these circumstances in situ, provided the confidence to be able to determine reliably corrosion under scabbing.
