HOMC APPLICATION NOTE-3

Corrosion Assessment at Simple Resting Supports

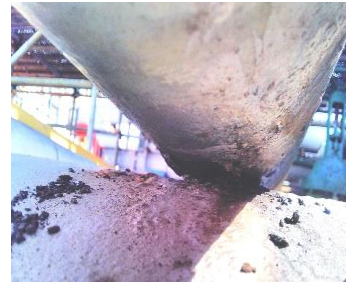
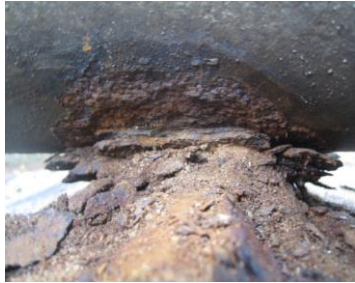
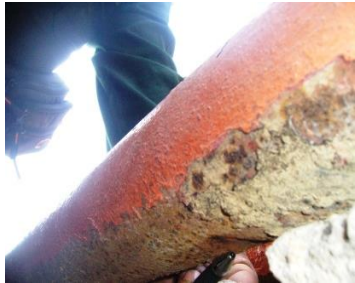
Uninsulated or bare piping resting directly on structural steel or over soil with a round bar have resulted in repeated corrosion problems posing high risks for pipe leaks. The geometry of bare piping resting on structural steel or on the ground with a corroding round bar provides a crevice that allows water to be trapped.

Since the paint system is designed to withstand atmospheric exposure and not immersion service, it softens over a period of time under the influence of trapped moisture. Eventually the pipe protective coating fails due to pipe movement on structural steel surface exposing the bare steel surface to water (which is often with high chlorides in a saline environment such as encountered in the middle east region or on offshore platforms) and starts to corrode. The crevice holds moisture and consequently results in accelerated corrosion rate. It is worthwhile noting that even if the pipe and support are made from same material such as carbon steel, the metallurgical difference can provide a small potential difference to drive the formation of a corrosion cell. Crevice corrosion thus leads to a potentially hazardous situation for the piping system.

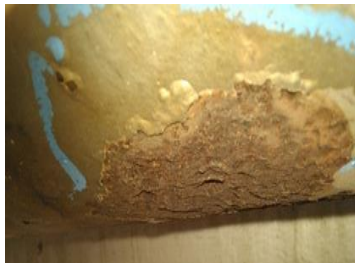
The main challenge to such inspection is the ability to size the corrosion reliably as many systems detect the same. Sizing is related to pipe size, accessibility, shape and nature of corrosion. The ability to size deep pitting on general / gradual corrosion. Corrosion at elbows and pipes that are closely spaced pose challenged to inspection. Visual inspection is not useful if corrosion does not extend beyond the point of resting.

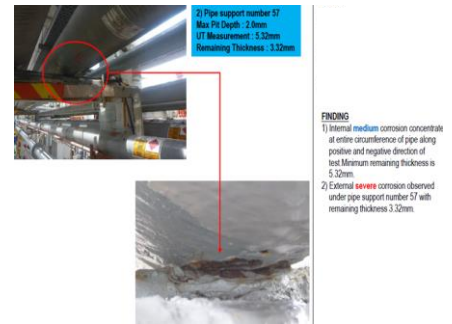
A 12inch Pipe in service had been inspected earlier by Visual inspection and pit depth and UT adjacent to the support in the accessible region was obtained. Wall loss identified though severe (3.32mm remaining) did not reflect the potential deepest corrosion due to access issues. The wall loss thus had to be estimated reliably for suitable engineering assessment for pipeline fitness for service.

Axial HOMC (AHOMC) in the through transmission TT Mode was conducted and the severity of wall loss was estimated to be much more severe than originally estimated previously. Wall loss of up to 61-70% of a reduced average thickness of around 5.0mm (general corrosion in the pipe) was determined. Remaining thickness of around. Predicted remaining wall thickness by HOMC was 1.5-1.95mm. The severity determined on lifting the pipe matched the same with a few localized deeper spots within 10%.

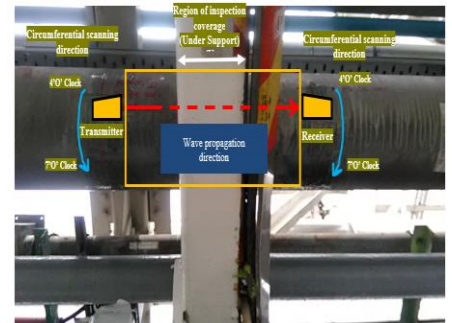
FINDING
 1) Internal medium corrosion concentrate at entire circumference of pipe along positive and negative direction of least Minimum remaining thickness is 5.32mm
 2) External severe corrosion observed under pipe support number 57 with remaining thickness 3.32mm.

61-70% Wall Loss based on a measured average thickness of 5.00-5.90 mm

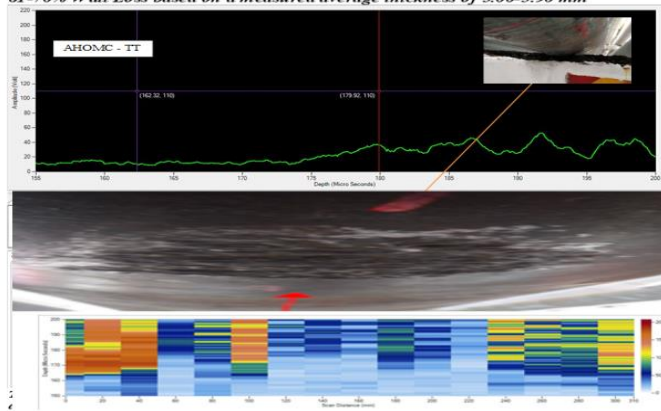
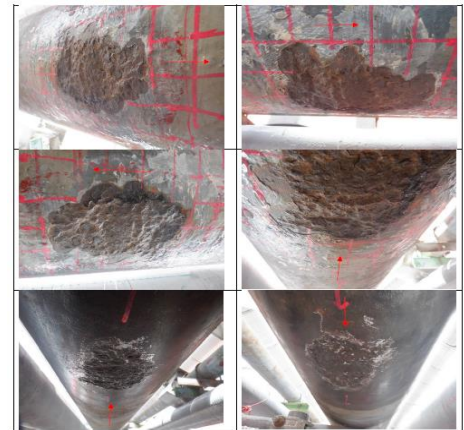
Note: The deepest corrosion profile between the two probes seen across the pipe circumference is as highlighted in red.

A 12 inch pipe with corrosion at the support near the elbow of the pipe was inspected with Axial HOMC (AHOMC) in the TT Mode 51-60% Wall Loss based on a measured average thickness of 9.30-9.50 mm was estimated along with the cross-sectional extent across the circumference as well. The client could take decisive action for mitigation of the corrosion based on HOMC results
