HOMC APPLICATION NOTE-1

Corrosion Assessment Under Welded Supports / Saddles

30inch Discharge Line Welded Support Failure Assessment Case Study

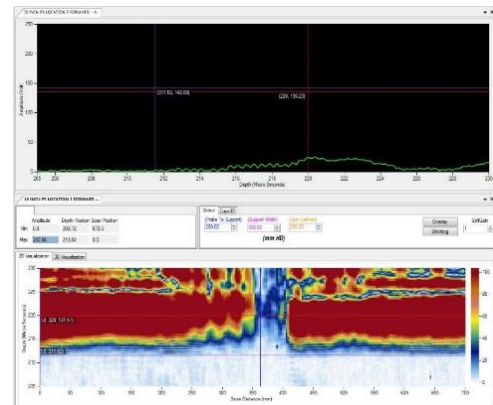
The Higher Order Mode Cluster (HOMC) Ultrasonic Guided waves are unaffected by the welds in the welded support and can resolve closely spaced defects. It also provided accurate sizing along with a cross sectional profile of the corrosion for easy visualization and engineering integrity assessments.
